Report on AES 003 1.3 GHz 9-cell Superconducting Niobium Cavity Test Results at LANL*

G. Ereemeev[†], A. Canabal, T. Tajima, A. Bhatti, F. Krawczyk, R. Roybal
LANL, Los Alamos, NM 87544, USA

Abstract

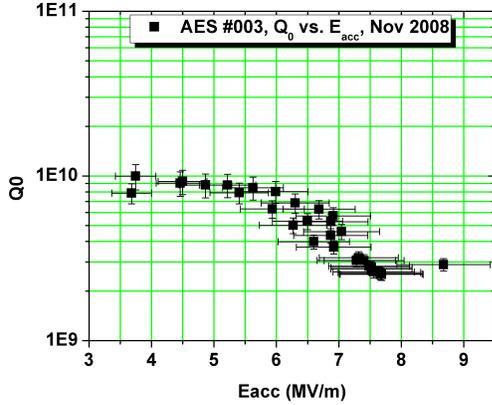
The quality factor of the cavity at 2 °K as a function of field in the π mode is presented in Fig. 1. The highest field was limited by the available power. X-ray radiation up to 8 R/h was registered at the highest field in the π mode by the X-ray sensor at the top lid of the cryostat. A quality factor close to 10^{10} was measured at low fields, but it had strong field dependence due to field emission, dropping to $3 \cdot 10^9$ at $E_{acc} \cong 8$ MV/m.

Figure 1: The quality factor of AES 003 as a function of field gradient in the π mode. The highest field was limited by available power (200W at the output of amplifier). The quality factor degradation is due to the field emission. Error bars were calculated from the variation in the calibration data measured at several points.

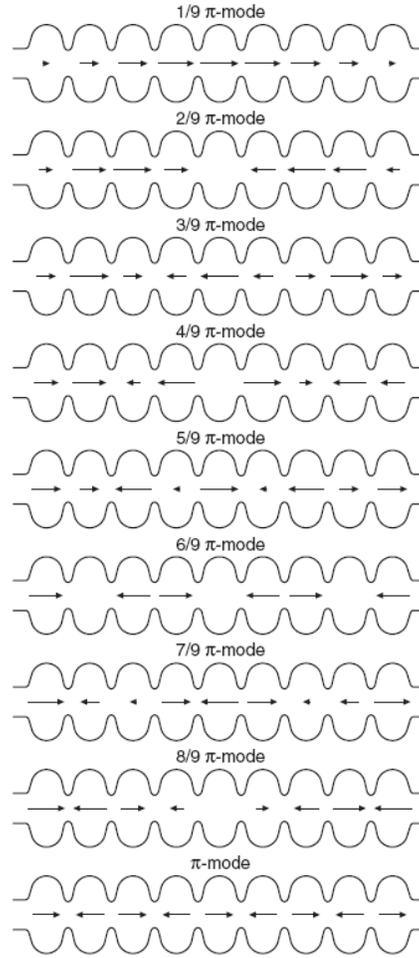
Figure 2: The field distribution in the cavity for different modes [5].

In order to avoid the field emission problem the cavity was tuned to other modes. For reference, in Fig. 2 the field distribution for each modes is presented. The summary of results in other modes is presented in Table. 1. Notably, X-rays were detected also in the $6\pi/9$ mode.

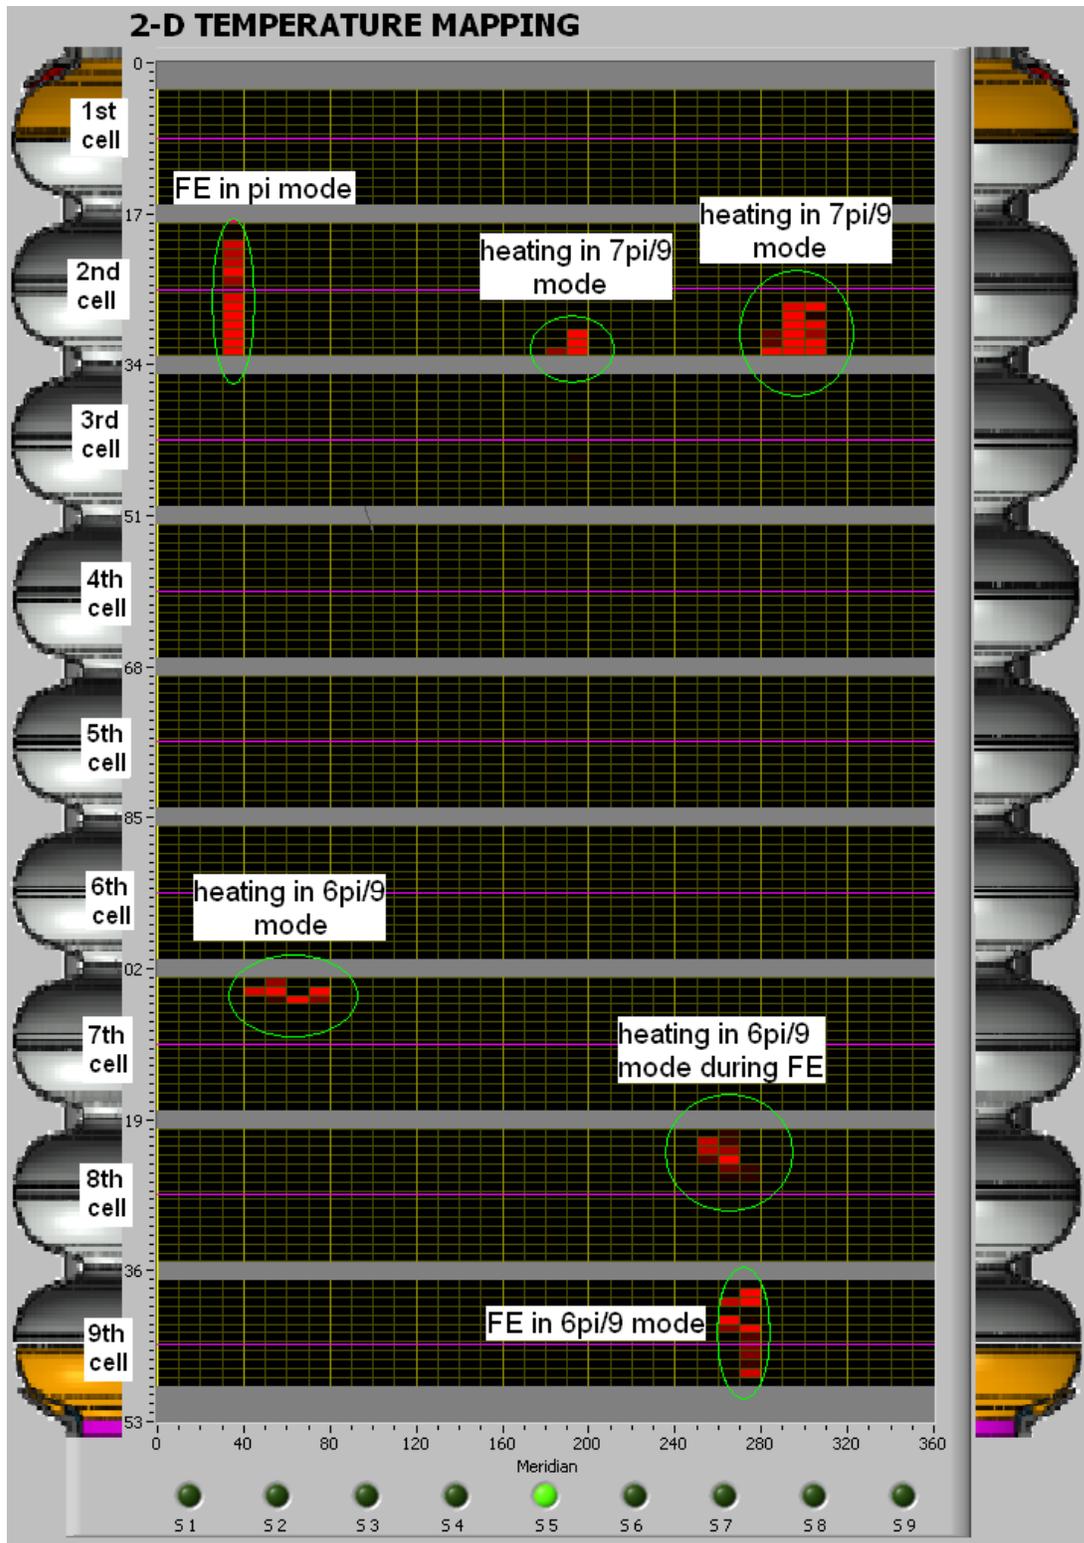
Figure 3: Summary of defects found on the cavity surface. The temperature scale and field scale are different for different hot-spots, so this picture only illustrates positions of different defects. The regions near cavity irises, where temperature sensors were not placed due to the interference with stiffening rings or disks at the end cells, were grayed out on the temperature map. For reference the cavity drawing is presented. Thermometers on equators are marked with magnets.

The cells were numbered from pickup coupler side. For the azimuthal direction, the center of HOM coupler on the pickup coupler side was set to 0 degree and the angle was shown clockwise looking the cavity from the pickup coupler side. For reference we put all heating areas found with thermometry system on the same temperature map, Fig. 3. Because these hot-spots were measured in different modes, at different field levels, they are not to be compared directly, they are presented only for a quick reference. All original temperature maps are presented in the Appendix. In the π mode the dominant source of losses was field emission in the 2nd cell. The temperature map clearly shows pattern, characteristic for field emission, see Fig. 15 in the Appendix. The field emission in the $6\pi/9$ mode was shown to be located in the 9th cell, see Fig. 14 in the Appendix. Heating was also observed in 8th cell, which has zero field in this mode. It is speculated that some electrons produced during field emission in the 9th cell, travelled to the 8th cell and deposited their energy there. Also, in the $6\pi/9$ mode distributed heating was observed in the 7th cell near the top iris, Fig. 13 in the Appendix. In the $7\pi/9$ mode two more heating areas were found by thermometry system in the 2nd cell, Fig. 11 and Fig. 12 in the Appendix. In other modes the highest achieved field was determined by available power without any heating registered by the thermometry system. It should be noted that the sensitivity of the thermometry was reduced by parasitic 60 Hz noise, present in the thermometry system throughout the tests.

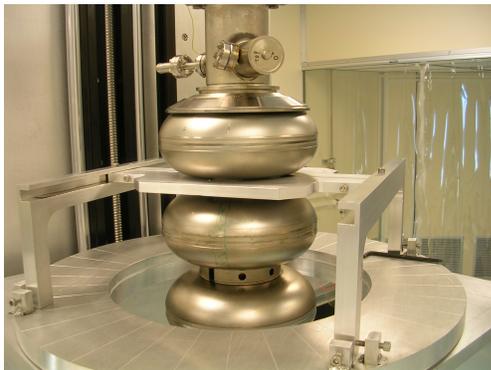
Figure 4: The top HOM coupler was used as a reference point to mark the position of the board zero of the thermometry system. Thermometry boards were placed every ten degrees in ascending order clockwise around the cavity as viewed from the top. For more information on the thermometry system, please, refer to [2].

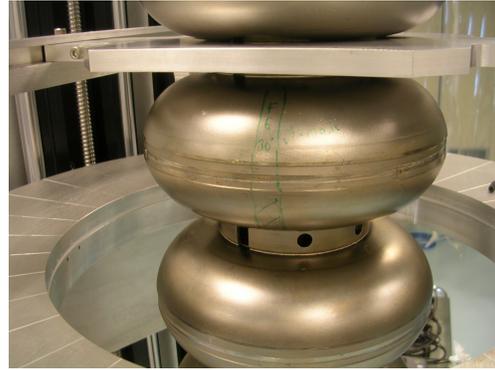
After the test the cavity was taken out from the cryostat. The thermometry system was disassembled, and the suspected lossy regions were marked, e.g. Fig. 5. After the cavity was degassed, removed from the test stand and

Figure 5: The position of the board, where field emission was observed, was marked after removing the thermometry system. These areas were closely examined during the surface inspection.

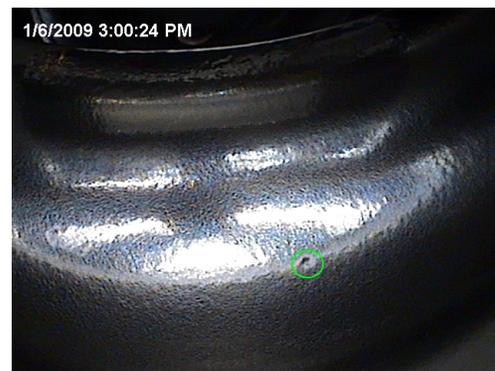
In the 2nd cell, near the iris between the 2nd and 3rd cells, we observed a pit in the stiffening ring weld, Fig. 6. We suspect this weld defect as a possible cause for field emission in the π mode.

Figure 6: The picture of the inside surface, where field emission heating was identified with the thermometry system. A defect, which is suspected to be the cause of field emission, was found on the stiffening ring weld, at the bottom of the cell, near the iris between the 2nd and 3rd cells, at 30 degrees.

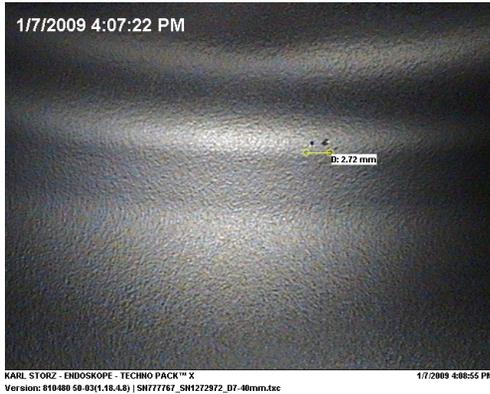
Another two hot-spots were indicated in the 2nd cell by

the thermometry system. They are marked as "heating in $7\pi/9$ mode" in Fig. 3. Inspecting the cavity, we found two surface defects about 1-2 mm from each other, Fig. 7, at about 190° at the bottom iris of the 2^{nd} cell, where the 9-cell thermometry system indicated excess heating during the RF test. No visible defects were found during examination of the 2^{nd} -cell's bottom iris at 280 - 300° , where the thermometry system also indicated a hot-spot. Here, however, the broad area of heating suggests a defect other than a small pit or a foreign inclusion on the niobium surface.

Figure 7: The picture of the inside surface on the bottom of the cell, near the iris between the 2^{nd} and 3^{rd} cells, at 190 degrees, where a defect heating was identified with the thermometry system. A defect found here on the inside surface is suspected to be the cause of heating.

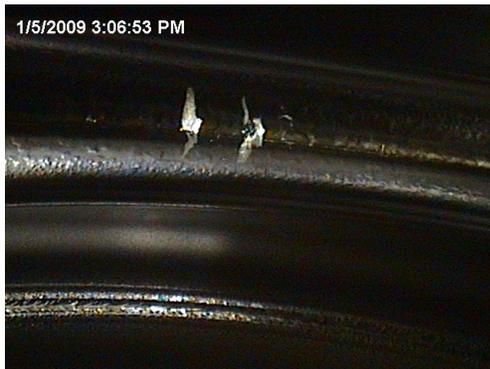
In the 6^{th} cell, near the top iris, another area was found to have higher losses as shown by the thermometry system, Fig. 3. During the surface inspection of the cavity we found two scratches at the iris between the 5^{th} and 6^{th} cell, Fig. 8, exactly at the location, where the thermometry indicated higher losses.

Figure 8: The picture of the inside surface of the iris between the 6^{th} and 7^{th} cells, at 70 degrees, where a defect heating was identified with the thermometry system. Two scratches on the surface are suspected to be the cause of excess dissipation.

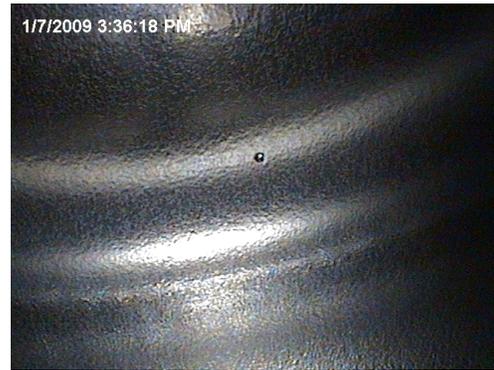
Another source of heating in the $6\pi/7$ mode was located

in the 9^{th} cell as was registered by the thermometry system. During visual inspection of that area we found a defect on the cavity surface, Fig. 9

Figure 9: The picture of the inside surface of the 9^{th} cell's bottom, at 260 degrees, where field emission was identified with the thermometry system. The defect found near the iris of the 9^{th} cell is suspected to be the cause of field emission.

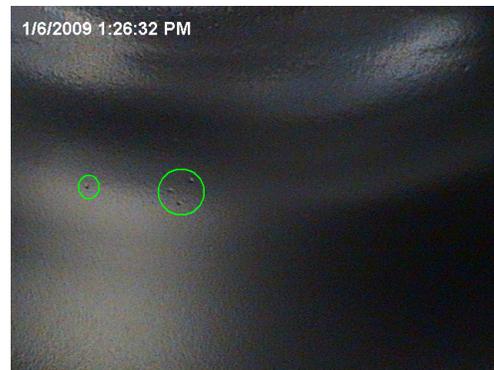
We also would like to note that during surface inspection a number of pits were found on the surface, Fig. 10. Though no excess of heating was measured near those defects with the thermometry system, these defect may cause a premature thermal breakdown at fields higher than those reached in the recent test.

Figure 10: The picture of the inside surface near the top iris of the 5^{th} cell, at 180 degrees, where no excess of dissipation was present on the temperature maps during the test. Yet, defects found here, and those found in other areas of the cavity present a potential problem for achieving high field.

the thermometry system. After the test the cavity was inspected with the new surface inspection system. Surface defects were found in areas that were lossy, as detected with the 9-cell thermometry system. A significant number of pit-like defects found on the cavity surface suggest a poor quality of niobium material, which must be improved if high gradients are to be achieved.

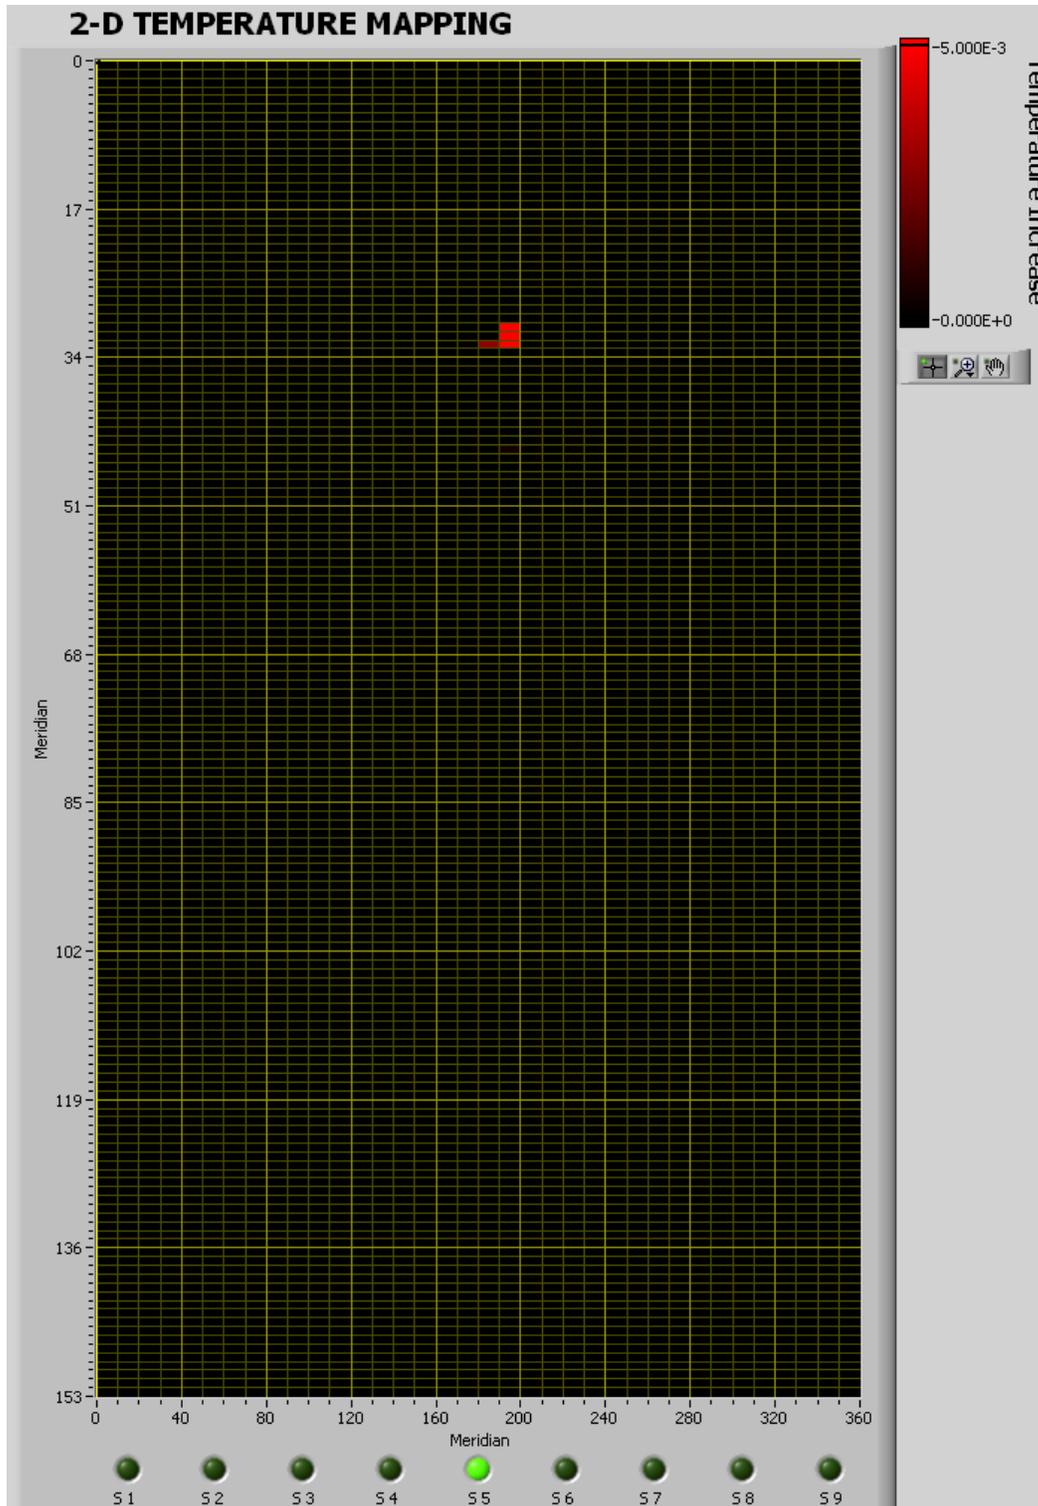
Figure 11: The temperature map saved during testing in the $7\pi/9$ mode shows defect heating in the 2nd cell.

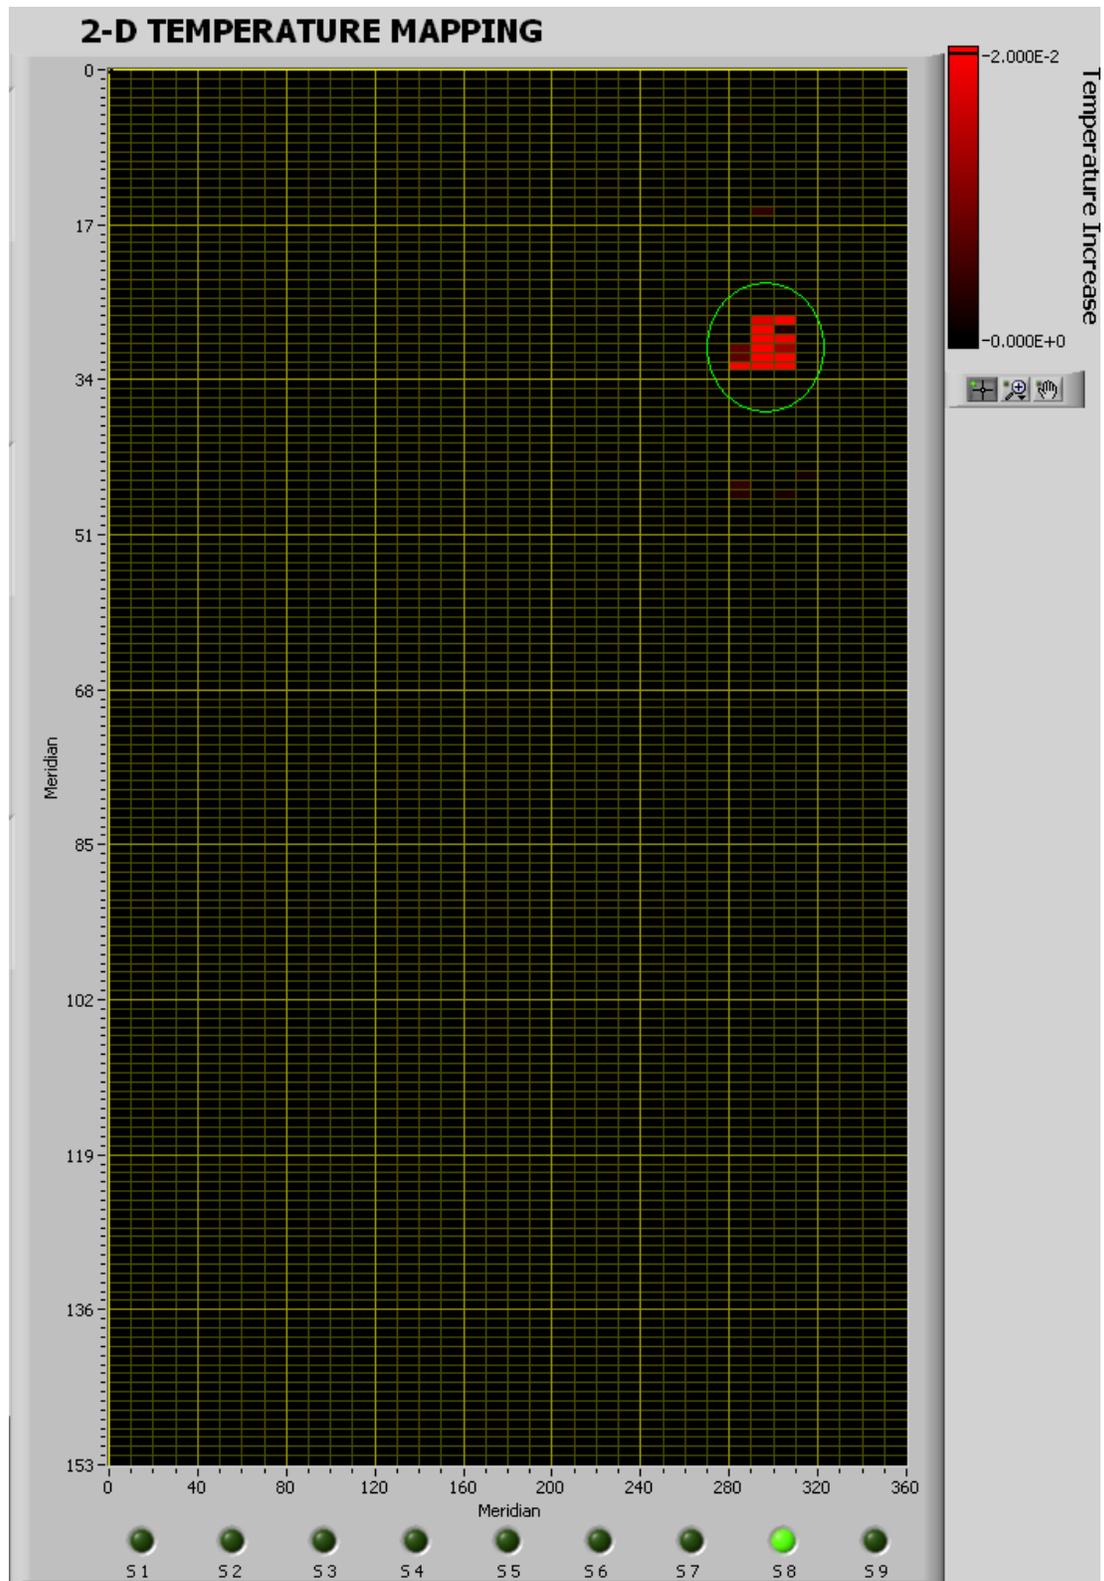
Figure 12: The temperature map saved during RF testing in the $7\pi/9$ mode shows excess heating in the 2^{nd} cell.

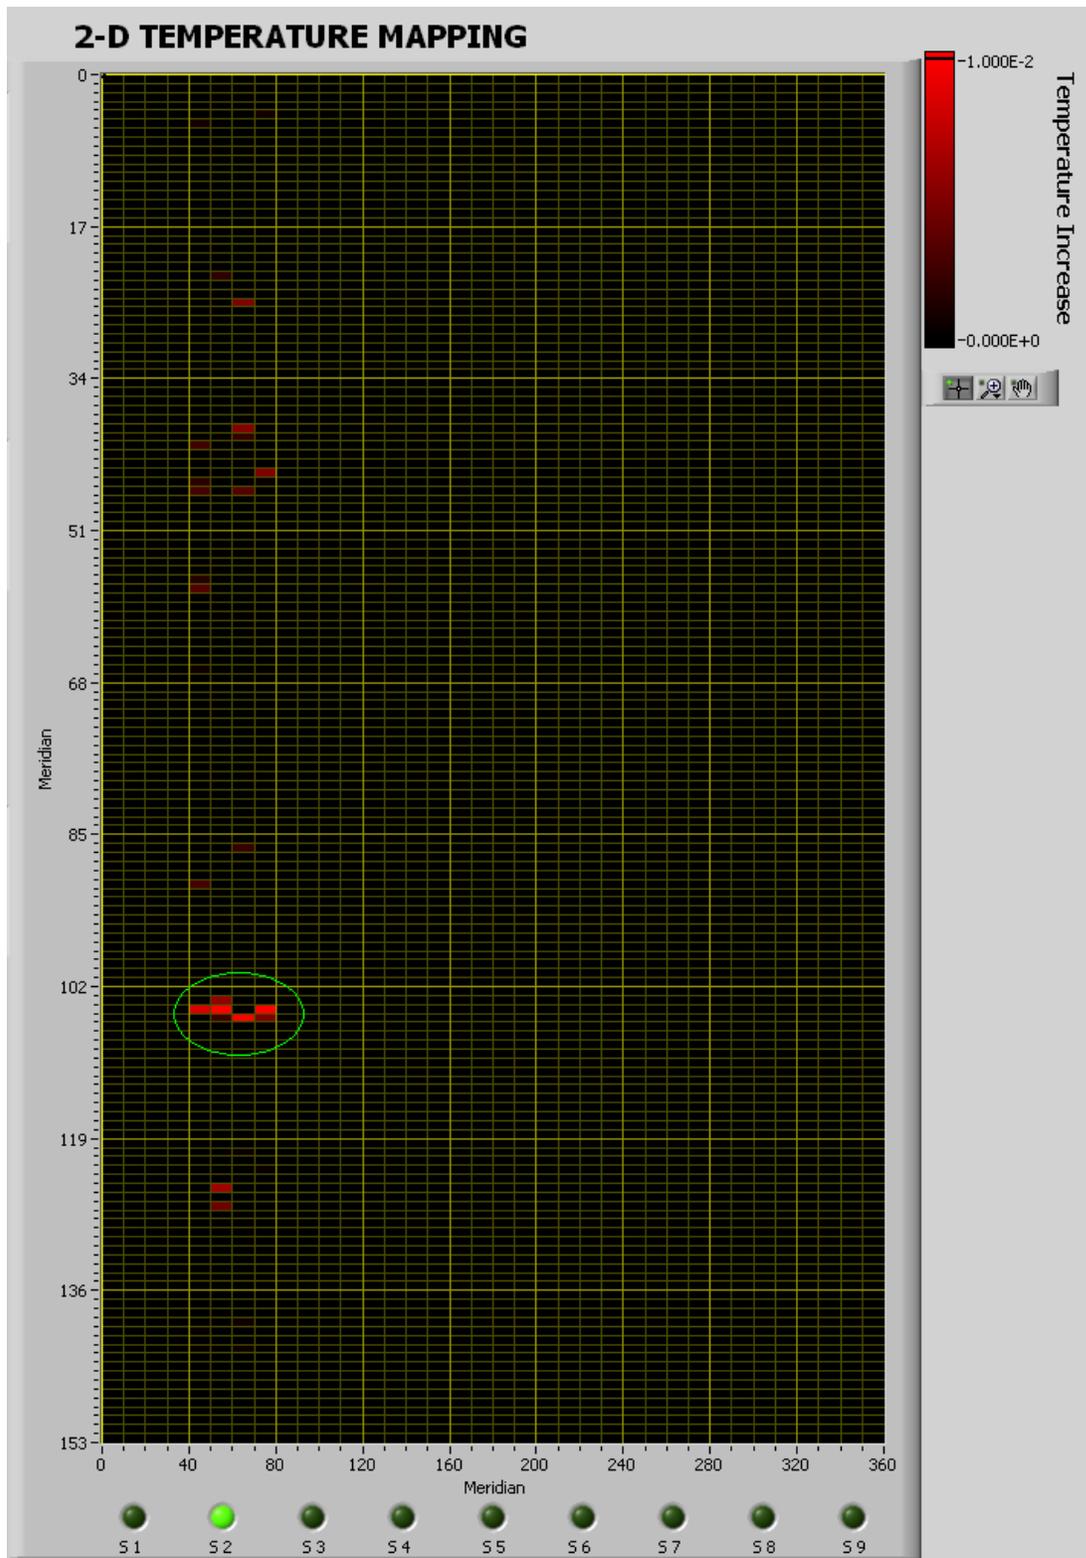
Figure 13: The temperature map saved during RF testing in the $6\pi/9$ mode shows excess heating in the 7th cell.

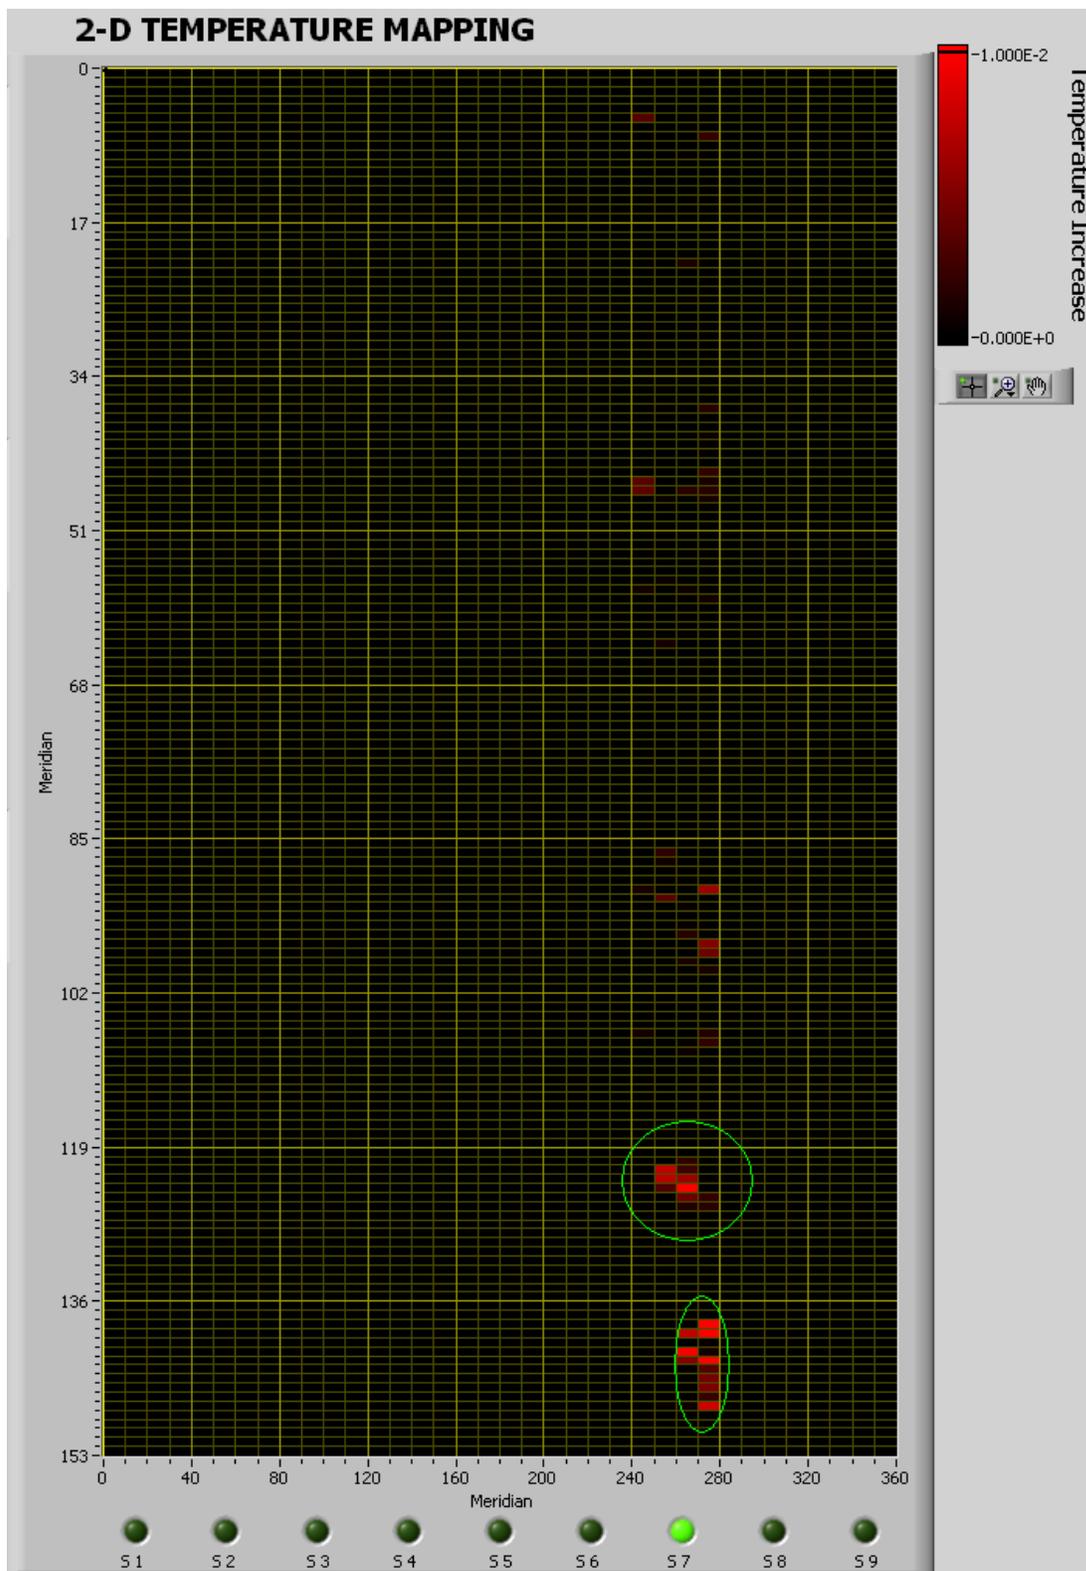
Figure 14: The temperature map saved during RF testing in the $6\pi/9$ mode shows excess heating in the 9th cell.

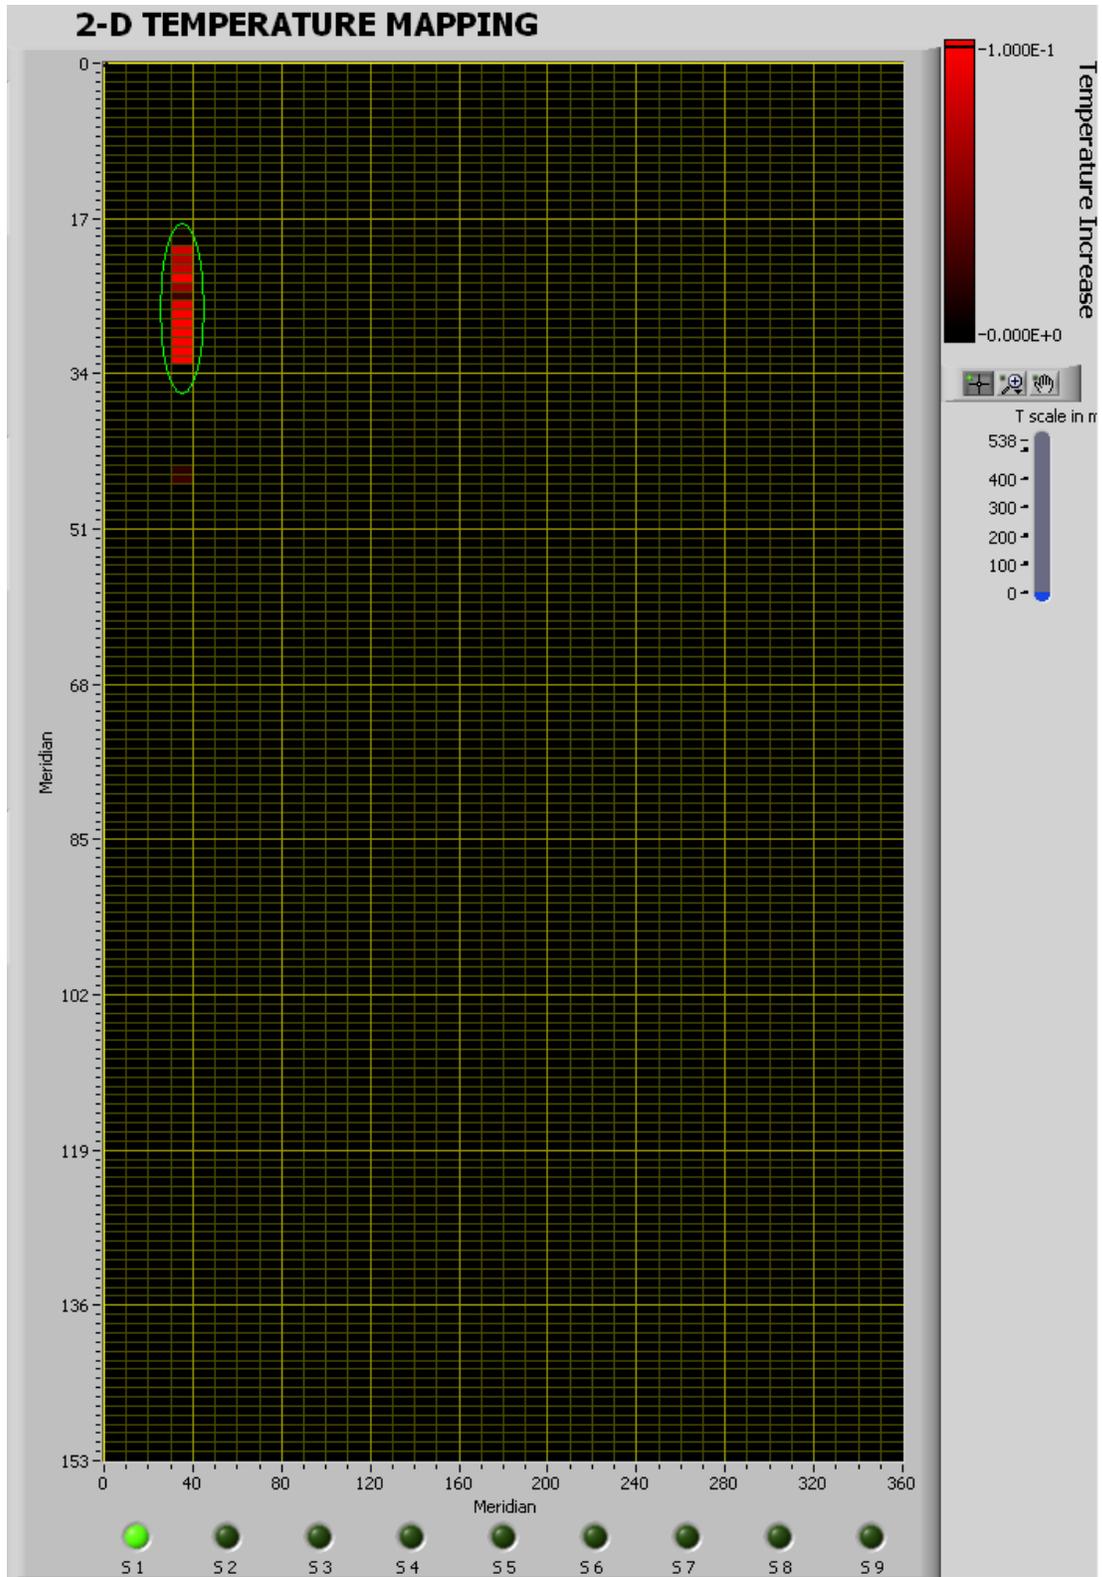
Figure 15: The temperature map saved during RF testing in the π mode shows field emission heating in the 2th cell. This heating was the ultimate limitation in RF performance of the cavity in the π mode.
